**ASBESTOS SURVEY AND ASSESSEMENT FOR THE  
CHILD CARE HOUSE  
SOUTHERN UTAH UNIVERSITY  
43 SOUTH 200 WEST  
CEDAR CITY, UTAH 84720**

**DFCM PROJECT NUMBER: 10159300**

**September 20, 2010**

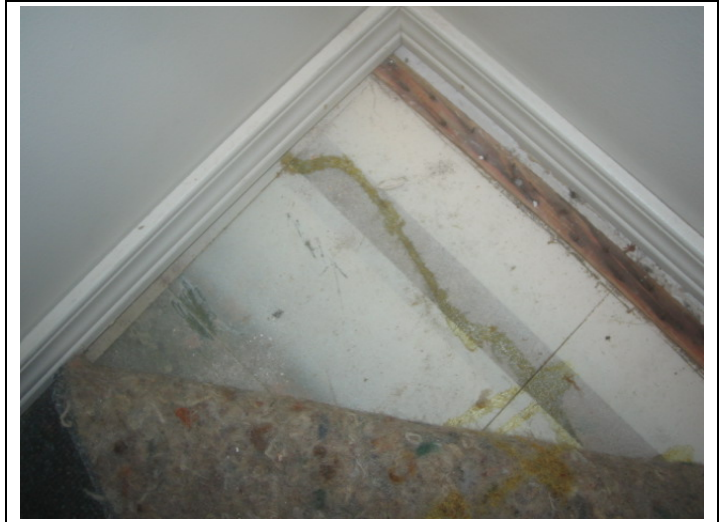
**PHOTO 2**

1. Exterior view, West Elevation
2. Floor tile contains asbestos. Homogeneous Area M01
3. Floor tile contains asbestos. Homogeneous Area M02

The mastic is non-friable ACMs. NESHAP regulations require the removal of non-friable ACMs before they are **disturbed and made friable** during renovation activities. Therefore, we recommend that all of these materials be removed and properly disposed of by a licensed asbestos abatement contractor before renovation activities begin **which have the potential of disturbing and making these materials friable**. The removal project must follow the requirements of the OSHA regulation outlined in 29 CFR 1926.1101. While these materials remain in place, a comprehensive asbestos O&M program should be implemented when the building is occupied to reduce human exposure to airborne asbestos fibers.
