**HAZMAT (ASBESTOS & LEAD PAINT) SURVEY AND ASSESSMENT  
SOUTHERN UTAH UNIVERSITY  
ENGINEERING AND TECHNOLOGY BUILDING  
CEDAR CITY, UTAH**

**January 29, 2007**

**ASBESTOS SURVEY AND ASSESSMENT  
SOUTHERN UTAH UNIVERSITY  
ENGINEERING AND TECHNOLOGY BUILDING  
CEDAR CITY, UTAH**

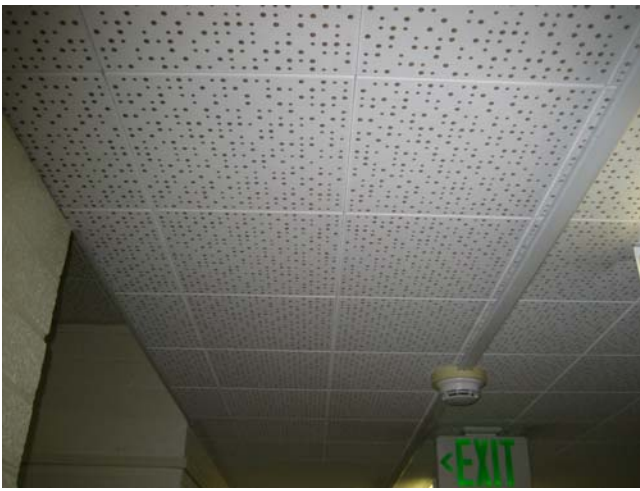
**Photograph 1-SUU ENGINEERING & TECHNOLOGY BUILDING**  
Non-ACM, 12" ceiling tile random dot pattern

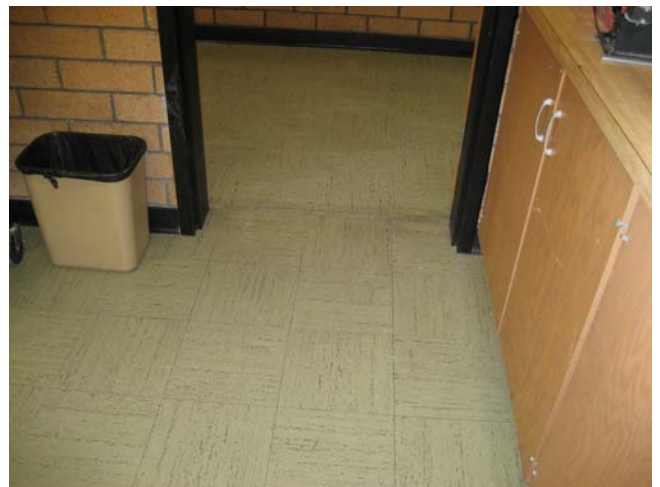
| <b>Material (1)<br/>ID #</b> | <b>Material<br/>Description</b> | <b>Location</b> | <b>Asbestos<br/>Content (2)</b> | <b>Quantity</b> | <b>Cost<br/>Estimate (3)</b> |
|---|---|--|---|---|---|
| M002 | 12" floor tile<br>(green w/speckles)<br>w/black mastic | Main floor | 8% C tile<br>>1% C mastic | ~9,655 sq. ft. | \$19,310.00<br>@\$2.00/sq. ft. |

**Photograph 4-SUU ENGINEERING & TECHNOLOGY BUILDING**  
M002: ACM 12" floor tile, room 119 Graphics Lab.

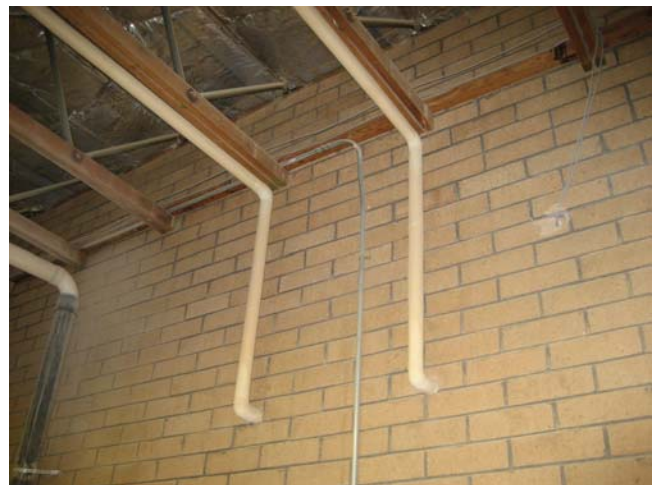
| <b>Material (1)<br/>ID #</b> | <b>Material<br/>Description</b> | <b>Location</b> | <b>Asbestos<br/>Content (2)</b> | <b>Quantity</b> | <b>Cost<br/>Estimate (3)</b> |
|---|---|--|---|---|---|
| T001 | Thermal System<br>Insulation (TSI)<br>Joints/fittings<br>Mudded | Rooms 005A-C,<br>004, 106, 101B,<br>above ceilings,<br>pipe chases | 10% C<br>15% C<br>40% A<br>2% C | ~150 each | \$3,000.00<br>@\$20/fitting |

**Photograph 6-SUU ENGINEERING & TECHNOLOGY BUILDING**  
T001: ACM TSI joints/fittings, room 106 Wood Lab.

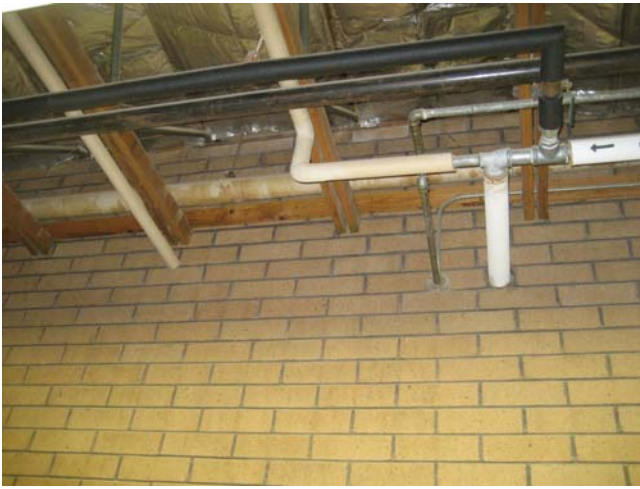
**Photograph 7-SUU ENGINEERING & TECHNOLOGY BUILDING**  
T001: ACM TSI joints/fittings, room 106 Wood Lab.

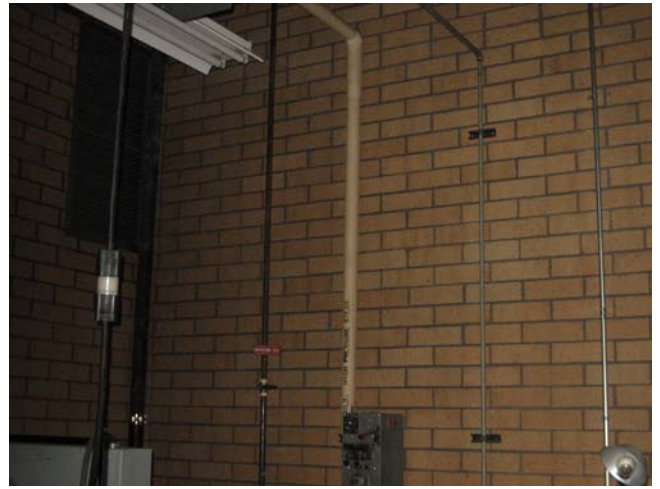
**Photograph 8-SUU ENGINEERING & TECHNOLOGY BUILDING**  
T001: ACM TSI joints/fittings, room 101B Machine Shop.

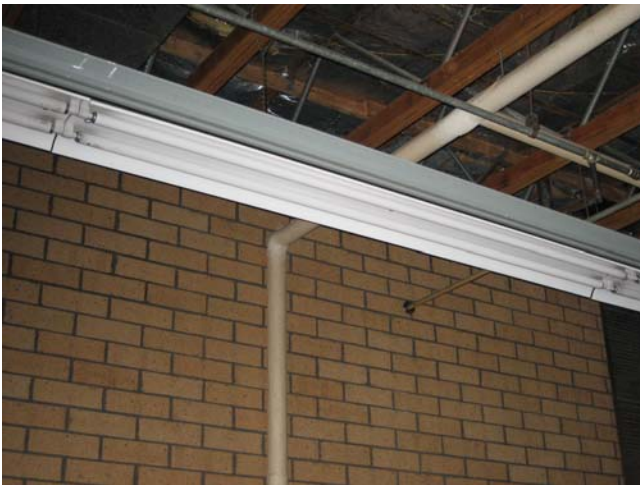
**Photograph 9-SUU ENGINEERING & TECHNOLOGY BUILDING**  
T001: ACM TSI joints/fittings, room 101B Machine Shop.

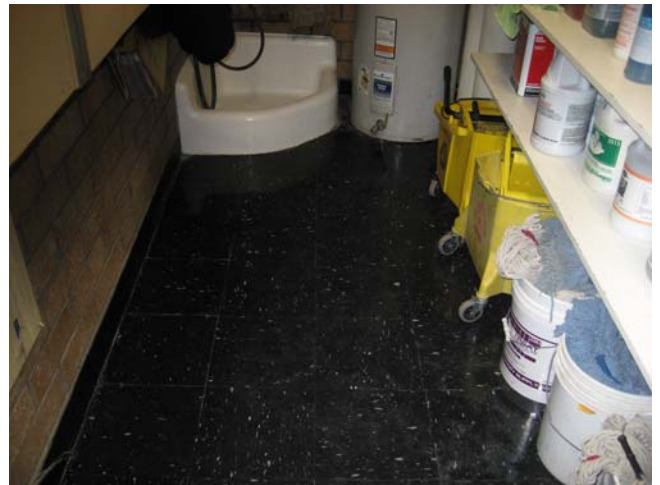
| <b>Material (1)<br/>ID #</b> | <b>Material<br/>Description</b> | <b>Location</b> | <b>Asbestos<br/>Content (2)</b> | <b>Quantity</b> | <b>Cost<br/>Estimate (3)</b> |
|---|---|--|---|---|---|
| M004 | 12" floor tile<br>(black w/ white<br>streaks) | Room 104 | >1% C tile | ~58 sq. ft. | \$116.00<br>@\$2.00/sq. ft. |

**Photograph 10-SUU ENGINEERING & TECHNOLOGY BUILDING**  
M004: ACM 12" floor tile, room 104 Custodial Closet.

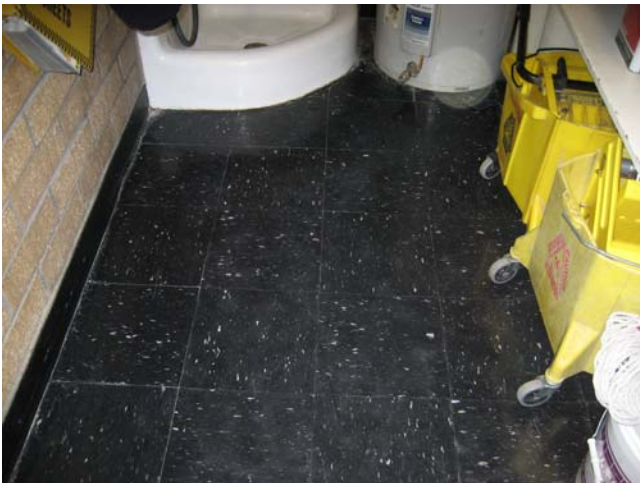
**Photograph 11-SUU ENGINEERING & TECHNOLOGY BUILDING**  
M004: ACM 12" floor tile, room 104 Custodial Closet.

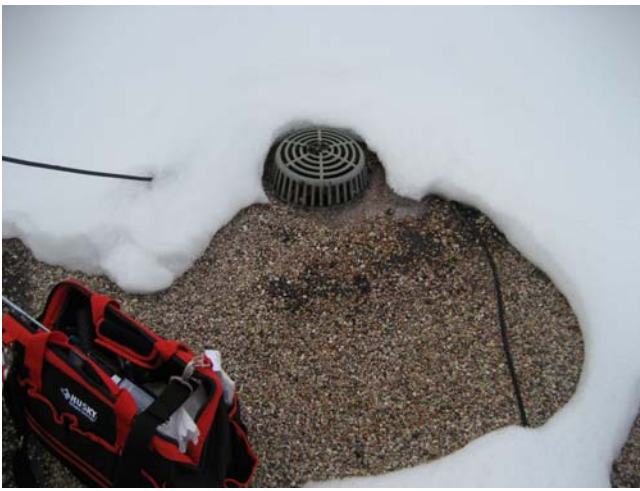
| <b>Material (1)<br/>ID #</b> | <b>Material<br/>Description</b> | <b>Location</b> | <b>Asbestos<br/>Content (2)</b> | <b>Quantity</b> | <b>Cost<br/>Estimate (3)</b> |
|---|---|--|---|---|---|
| M005 | Roof (built-up<br>w/rock ballast | Roof | 8% C 10% C | ~2,500 sq. ft. | \$12,500.00<br>@\$5.00/sq. ft. |

**Photograph 13-SUU ENGINEERING & TECHNOLOGY BUILDING**  
M005: ACM Roof (built-up w/rock ballast).

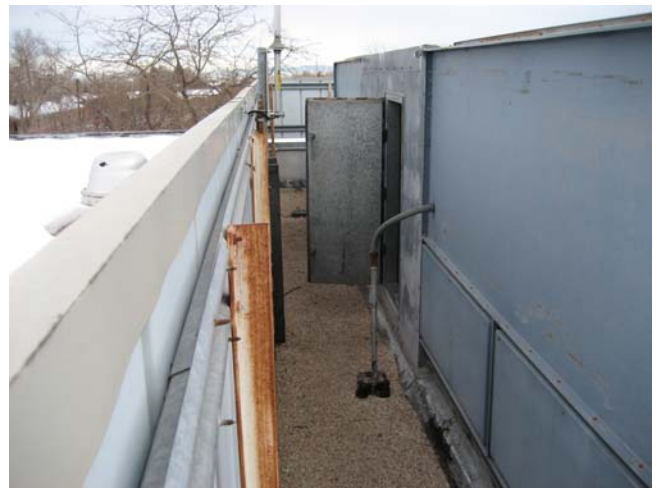
**Photograph 14-SUU ENGINEERING & TECHNOLOGY BUILDING**  
M005: ACM Roof (built-up w/rock ballast).

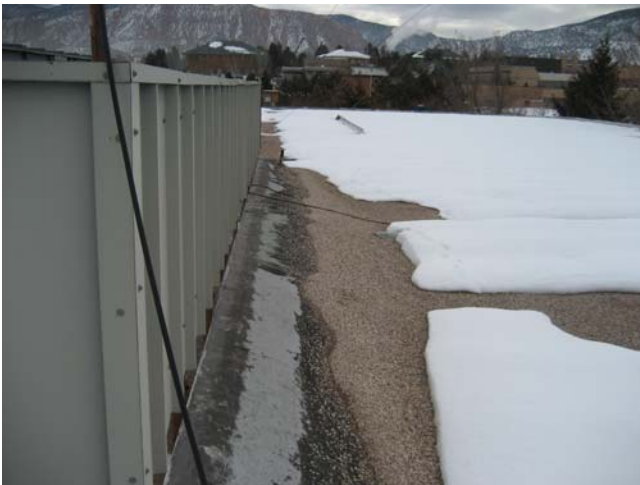
**Photograph 15-SUU ENGINEERING & TECHNOLOGY BUILDING**  
M005: ACM Roof (built-up w/rock ballast).  
Black & Silver tar sealant.

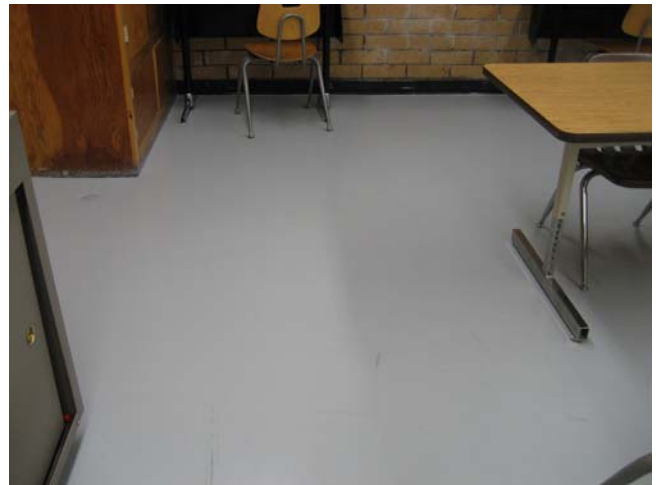
**Photograph 16-SUU ENGINEERING & TECHNOLOGY BUILDING**  
Room 112-Electronics Lab floor, non-ACM.
