**HAZMAT (ASBESTOS & LEAD BASED PAINT)  
SURVEY AND ASSESSMENT**

*Southern Utah University  
Eccles Coliseum  
Cedar City, Utah*

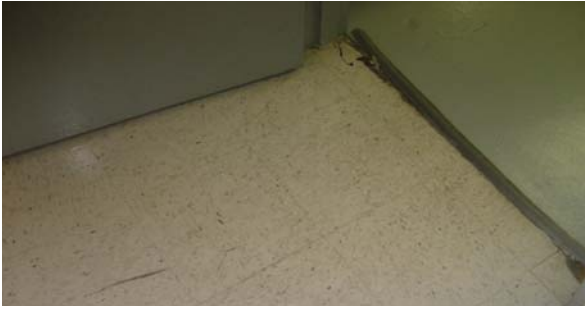
**Photograph 1- M001**  
12" Floor Tile, White w/Gray Streaks, No Mastic  
Hallway 106A, Room 106

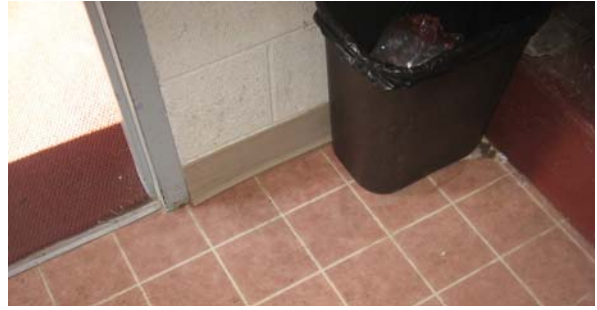
**Photograph 2-M003**  
Solid Vinyl Floor  
Training Room 106 D

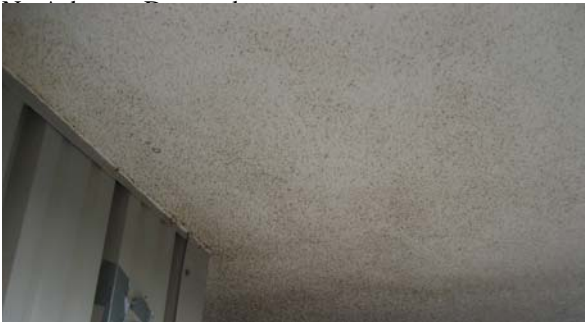
**Photograph 3- S001**  
Textured Ceiling Material  
Exterior Porch, Level 300
