**HAZMAT (ASBESTOS & LEAD PAINT SURVEY AND ASSESSMENT
SOUTHERN UTAH UNIVERSITY
FACILITIES/AUTOMOTIVE BUILDING
CEDAR CITY, UTAH**

SEPTEMBER 15, 2006

ASBESTOS SURVEY AND ASSESSMENT
SOUTHERN UTAH UNIVERSITY
FACILITIES/AUTOMOTIVE BUILDING
CEDAR CITY, UTAH

**SOUTHERN UTAH UNIVERSITY
FACILITIES/AUTOMOTIVE BUILDING
CEDAR CITY, UTAH**

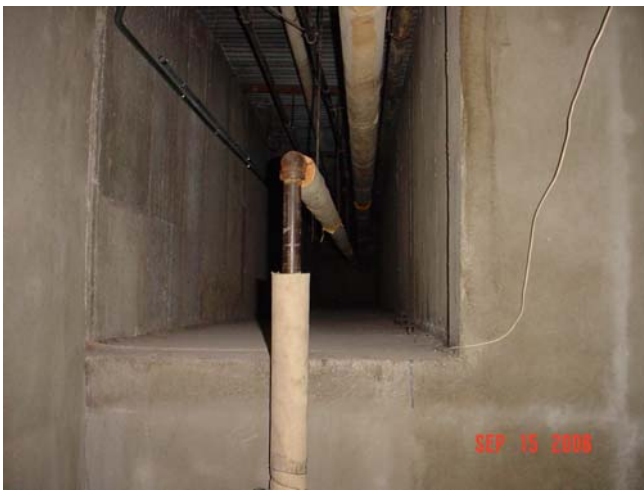
Photograph 1-SUU FACILTITES/AUTO
Room 001, TSI pipe lagging (fiberglass, NON-ACM).

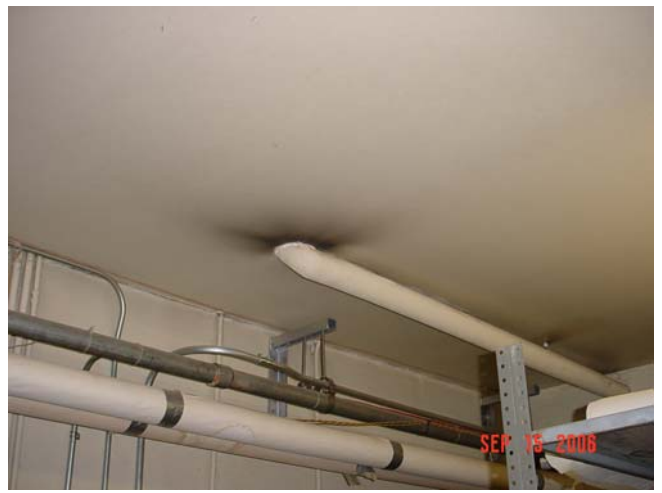
Area Number	Material Type	Substrate	Assessment Category	Damage	Accessibility	Disturb Potential
T001	Thermal System Insulation (TSI) Joints/fittings (mudded)	Metal	6	UNDAMAGED	PERIODIC	HIGH
M002	9" floor tile	Concrete	NA	UNDAMAGED	CONTINUOUS	LOW

Photograph 2-SUU FACILTITES/AUTO
Room 002, T001, TSI joints/fittings (mudded, ACM).

Homogeneous Area Number	Material	Amount	Unit Cost	Extended Cost
T001	Thermal System Insulation (TSI) Joints/fittings (mudded)	~40 each	@\$20/joint	\$800.00
M002	9" floor tile	~2,464 sq. ft.	@\$2/sq. ft.	\$4,928.00

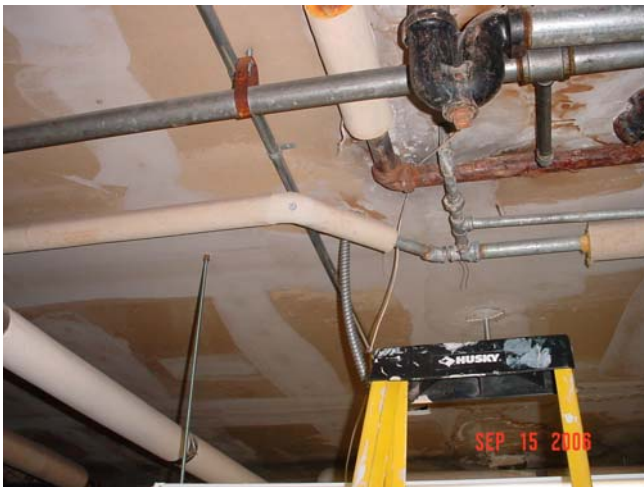
Photograph 3-SUU FACILTITES/AUTO
Room 001, T001, TSI joints/fittings (mudded, ACM).

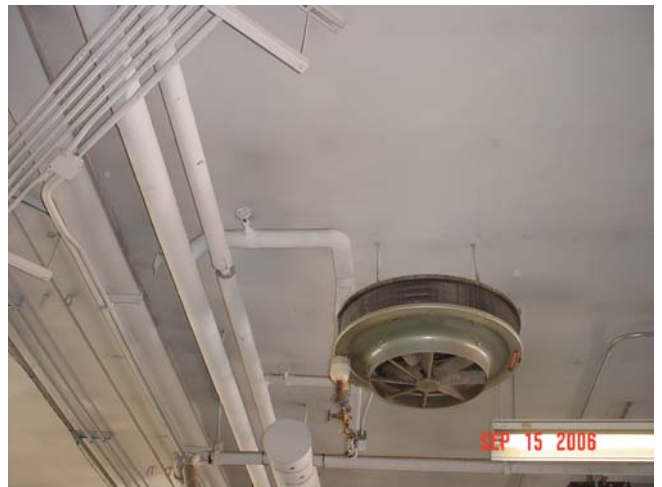
Photograph 4-SUU FACILTITES/AUTO
Automotive shop, T001, TSI joints/fittings (mudded, ACM).

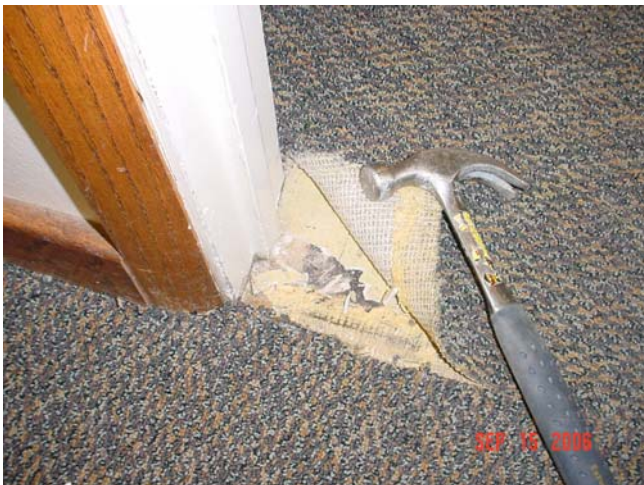
Photograph 5-SUU FACILTITES/AUTO
Facilities building, main hallway, M002 9" floor tile under carpet, ACM.

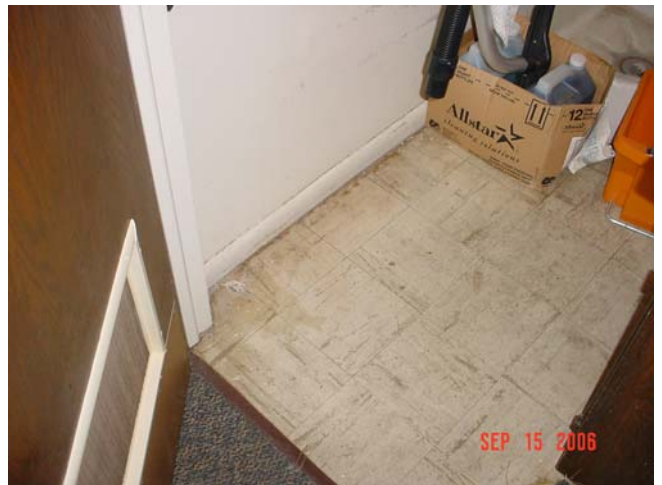
Photograph 6-SUU FACILTITES/AUTO
Room 107 custodial closet, M002, 9" floor tile, exposed, ACM.

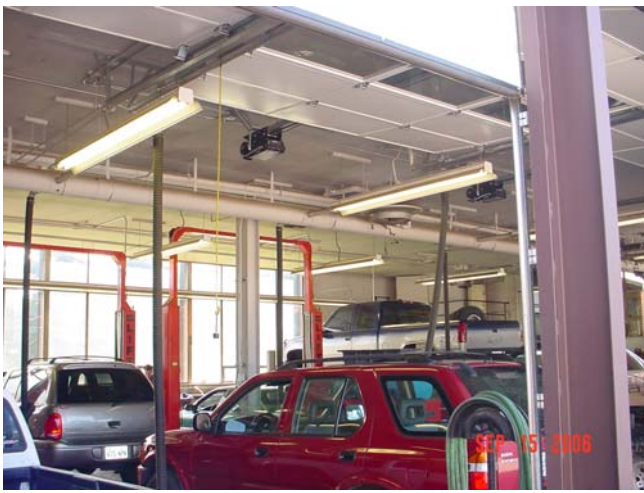
Photograph 7-SUU FACILTITES/AUTO
Auto shop, T001, TSI joints/fittings-mudded,
ACM.
