**HAZMAT (ASBESTOS & LEAD BASED PAINT)  
SURVEY AND ASSESSMENT**

*Southern Utah University  
General Classroom Building  
Cedar City, Utah*

On August 18, 2007, **ROWLAND CONSULTING, INC.** performed an asbestos survey and assessment at Southern Utah University, General Classroom Building in Cedar City, Utah. The purpose of this survey was to identify the existence, extent, and condition of both friable and non-friable asbestos-containing materials (ACM) within and on the facility. Bulk samples were collected from suspect materials, submitted to a laboratory, and analyzed for asbestos content. Each occurrence of ACM was assessed for damage and friability.

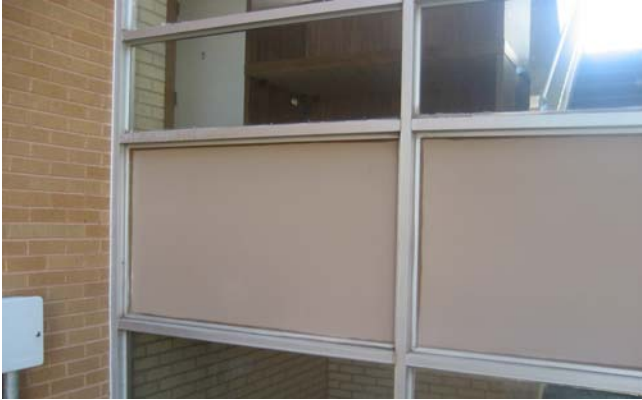
**Photograph 1- M007**  
**Window Caulking**  
**Exterior Windows**  
**Contains 5% Asbestos & LBP**

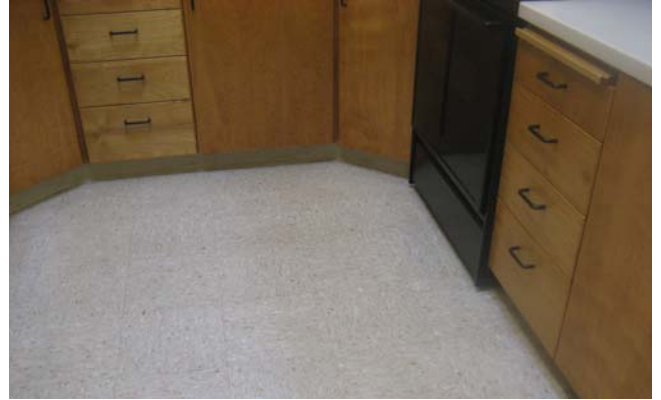
**Photograph 2-M002**  
**12" Floor Tile, Room 204 Foods Lab**  
**No Asbestos Detected**

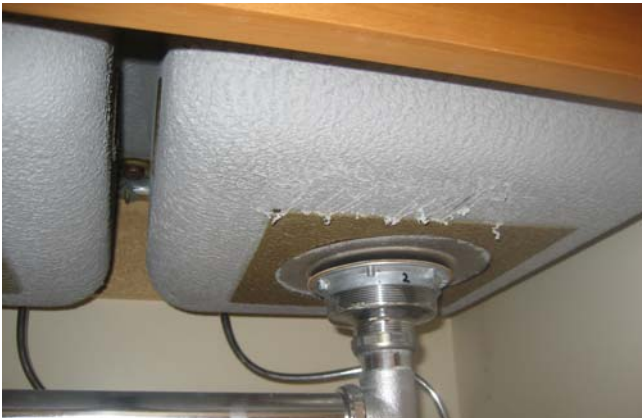
**Photograph 3-M003**  
**Sink Undercoating**  
**Room 204 Foods Lab**  
**No Asbestos Detected**

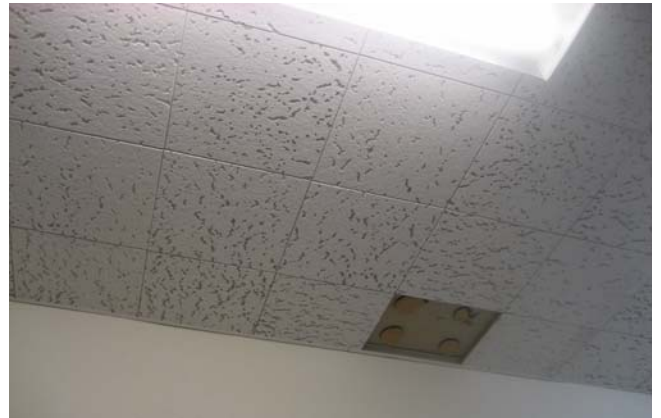
**Photograph 4- M004**  
**12" Ceiling Tile w/Adhesive**  
**100 E Corridor**  
**No Asbestos Detected**

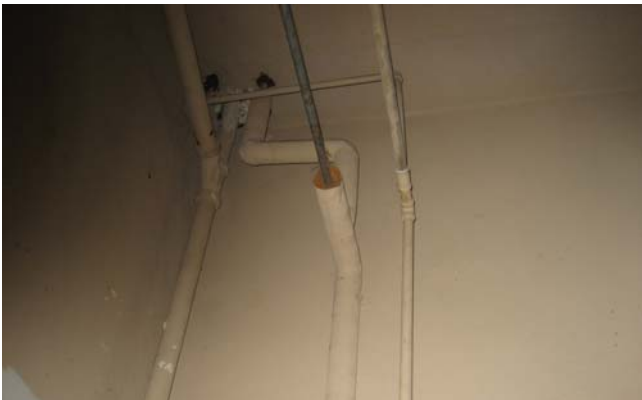
**Photograph 5- T001**  
**TSI Joints/Fittings, Mudded**  
**Room 111 Custodial**  
**No Asbestos Detected**

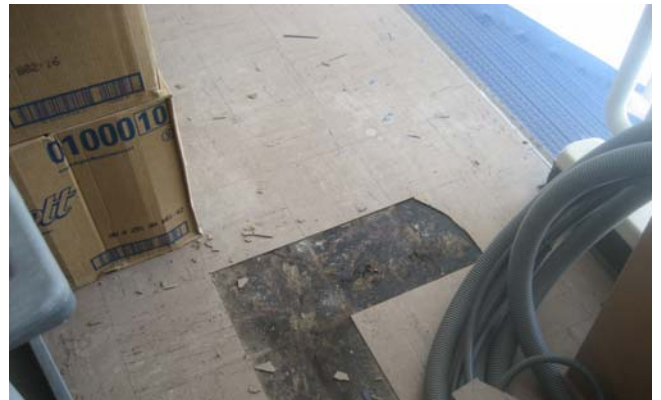
**Photograph 6- M006**  
**9" Floor Tile (mastic none detected)**  
**Level 500**  
**Contains 10% Asbestos**
