**ASBESTOS, LEAD AND HAZARDOUS MATERIALS
INSPECTION, SURVEY AND ASSESSMENT
FOR THE
RANDALL L. JONES THEATER
SOUTHERN UTAH UNIVERSITY
CEDAR CITY, UTAH 84720**

DFCM PROJECT NUMBER: 07056300

January 14, 2008

**David C. Roskelley, MSPH, CIH, CSP
R & R Environmental, Inc. (R & R)
47 West 9000 South, Suite #2
Sandy, Utah 84070
dave@rrenviro.com
Phone (801) 541-1035**

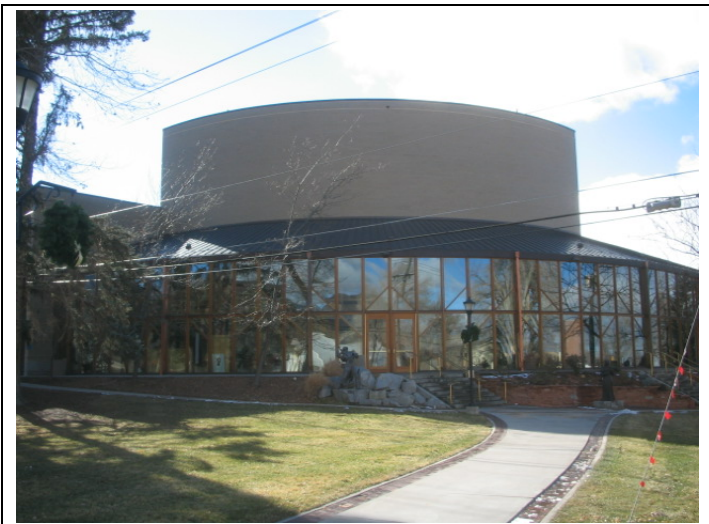
PHOTO 1

1. Exterior North elevation.
