**HAZMAT (ASBESTOS & LEAD PAINT) SURVEY AND ASSESSMENT
SOUTHERN UTAH UNIVERSITY
MUSIC BUILDING
CEDAR CITY, UTAH**

January 29, 2007

Prepared by:
ROWLAND CONSULTING, INC.
7301 South Paddington Road
West Jordan, Utah 84084
TEL 801.541.6915 FAX 801.569.2501

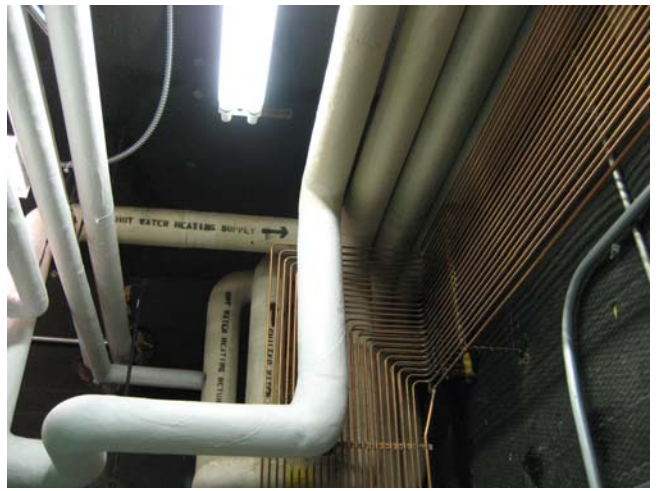
Photograph 2-SUU MUSIC BUILDING
Room 110, Mechanical room. **Asbestos TSI joint/fittings-mudded.** Pipe lagging straight runs are fiberglass insulation.

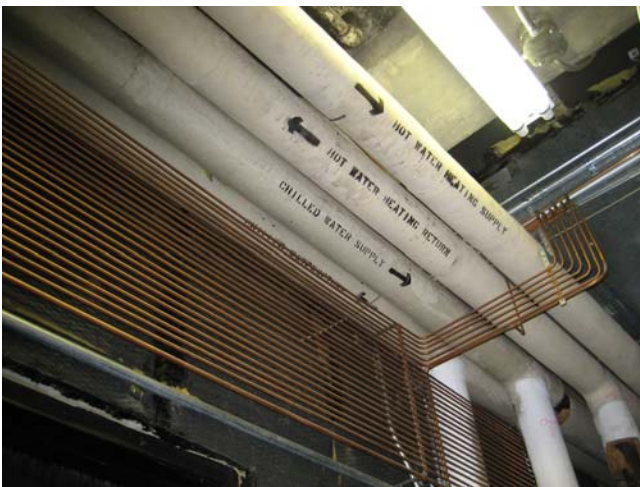
Photograph 3-SUU MUSIC BUILDING
Room 110, Mechanical room. **Asbestos TSI joint/fittings-mudded (T002).** Pipe lagging straight runs are fiberglass insulation.

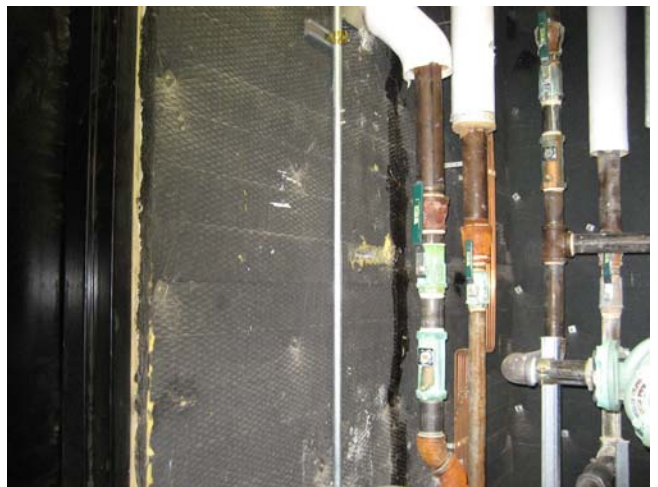
Photograph 4-SUU MUSIC BUILDING
Room 110, Mechanical room. **Asbestos Acoustical Liner (T001).**

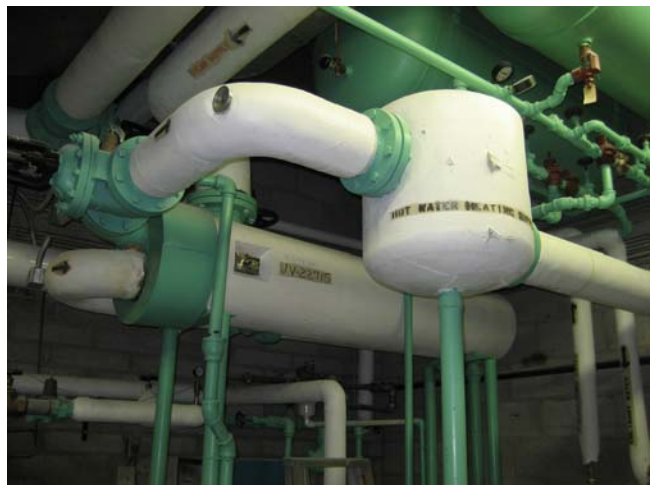
Photograph 6-SUU MUSIC BUILDING
Room 110, Mechanical room, T002, **Asbestos heat exchanger (background, horizontal).** Up from the floor ~7 feet.

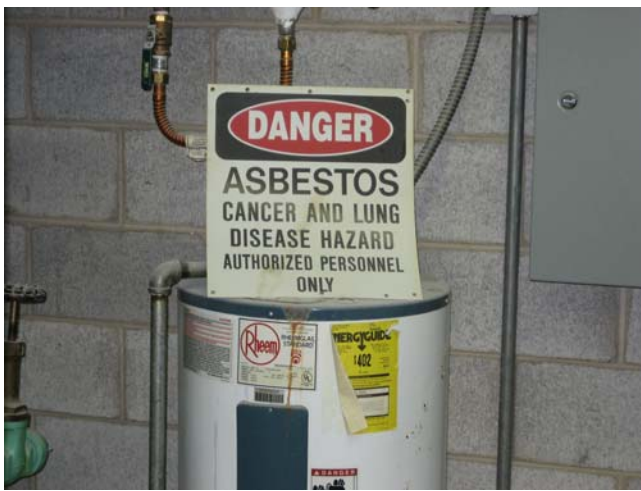
Photograph 7-SUU MUSIC BUILDING
Asbestos sign in Room 110, Mechanical room.

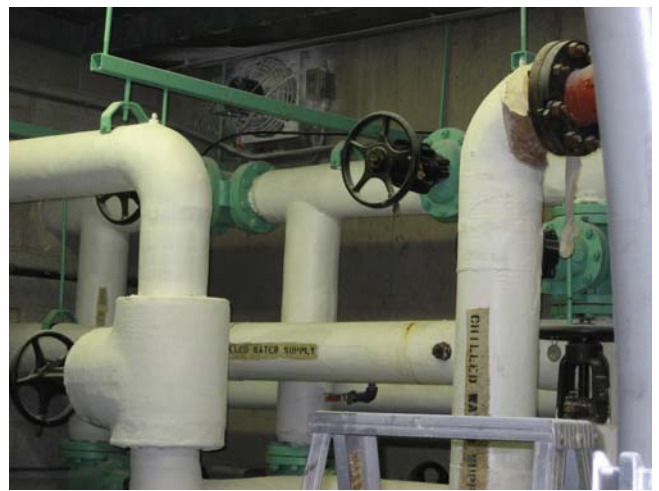
Photograph 8-SUU MUSIC BUILDING
Room 111, Mechanical room with Asbestos TSI joint/fittings-mudded.

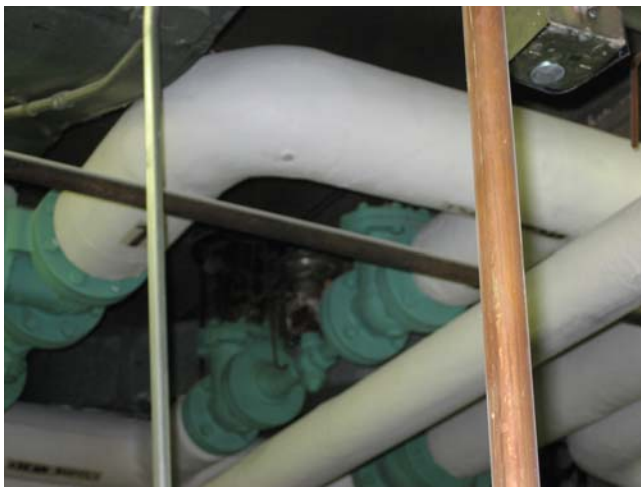
Photograph 9-SUU MUSIC BUILDING
Room 111, Mechanical room with Asbestos TSI joint/fittings-mudded.

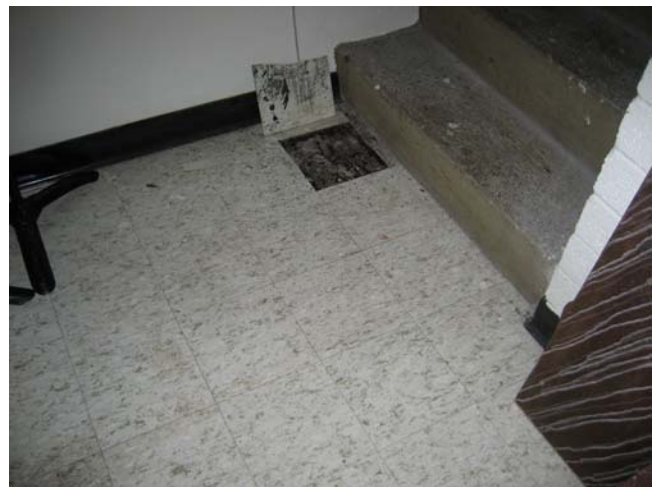
Photograph 10-SUU MUSIC BUILDING
Room 100C stairwell, Asbestos 9" floor tile (M001).

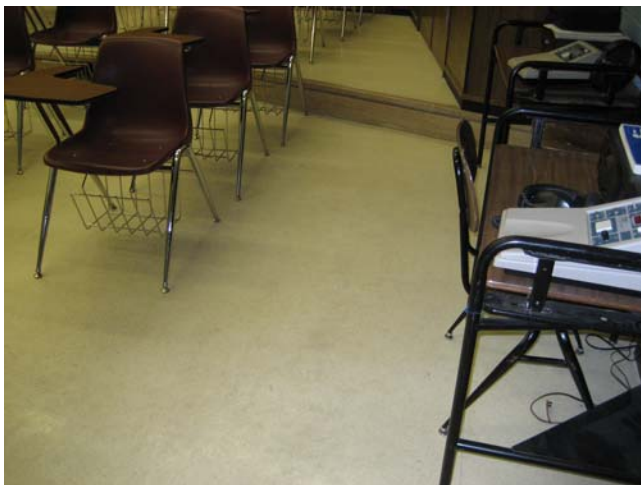
Photograph 11-SUU MUSIC BUILDING
Room 207 (classroom), Asbestos Sheet Vinyl Flooring (SVF-M004).

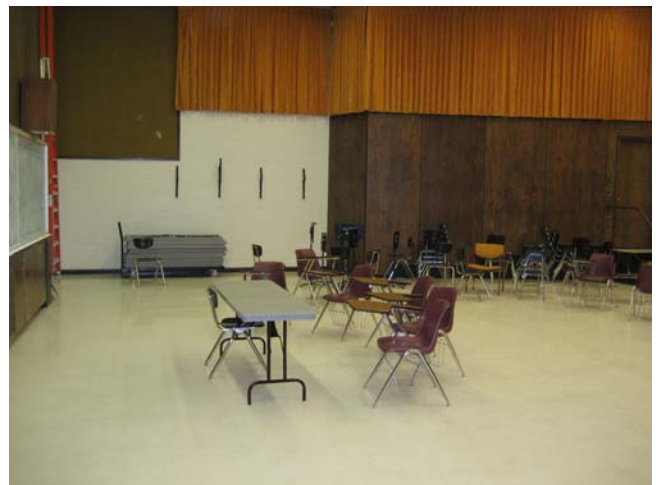
Photograph 12-SUU MUSIC BUILDING
Room 209 (rehearsal), Asbestos Sheet Vinyl flooring (SVF-M004).

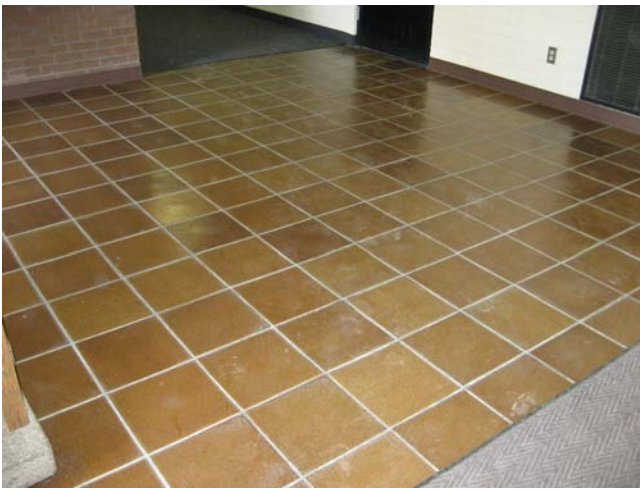
Photograph 13-SUU MUSIC BUILDING
Front entry ceramic tile, Lead containing glaze.

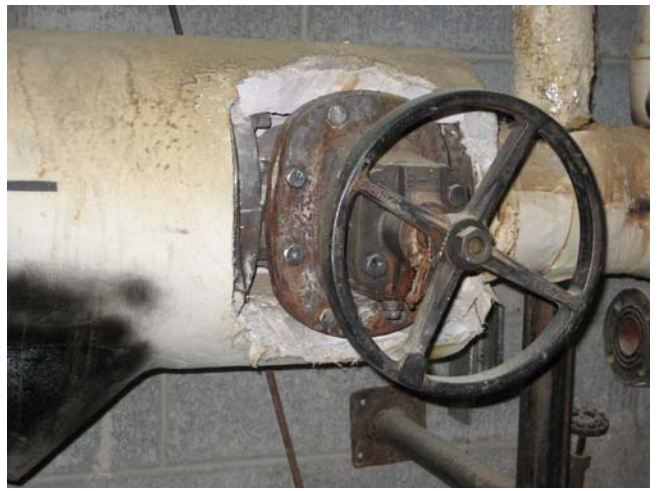
Photograph 14-SUU MUSIC BUILDING
Room 111, Asbestos TSI valve body.

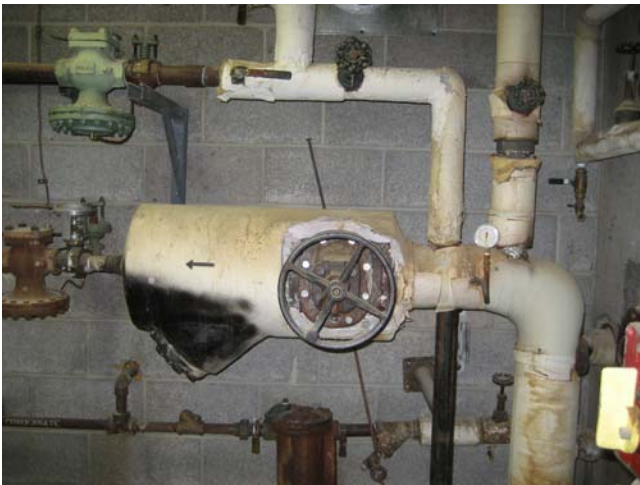
Photograph 15-SUU MUSIC BUILDING
Room 111, Asbestos TSI valve body.

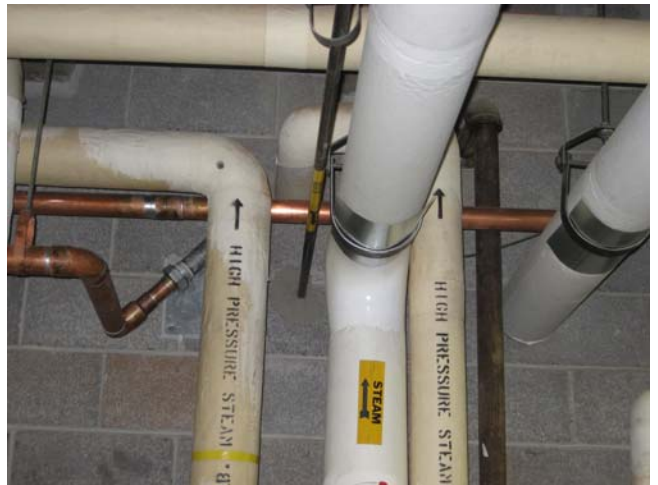
Photograph 16-SUU MUSIC BUILDING
Room 111, Mechanical room with Asbestos TSI joint/fittings-mudded.
