**ASBESTOS SURVEY AND ASSESSEMENT FOR THE  
CHILD CARE HOUSE  
SOUTHERN UTAH UNIVERSITY  
43 SOUTH 200 WEST  
CEDAR CITY, UTAH 84720**

**DFCM PROJECT NUMBER: 10159300**

**September 20, 2010**

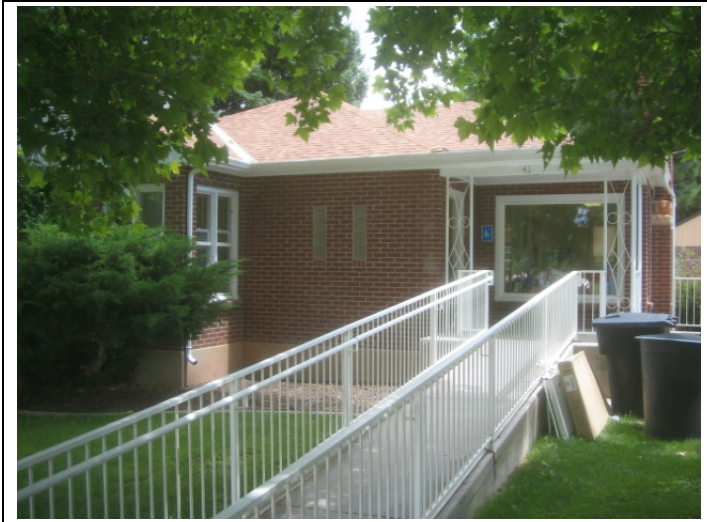
**PHOTO 1**

1. Exterior view, West Elevation
2. Floor tile contains asbestos. Homogeneous Area M01
3. Floor tile contains asbestos. Homogeneous Area M02
